VOLUME 1
SUMMARY REPORT ON SITE INVESTIGATION
AND REMOVAL ACTIVITIES
CSMRI CREEKSIDE SITE
GOLDEN, JEFFERSON COUNTY, COLORADO
TDDS T08-9202-017, T08-9205-018
T08-9210-011, T08-9210-012

Michael J. Sullivan
Ecology & Environment, Inc.
Technical Assistance Team

DATE SUBMITTED: March 17, 1993

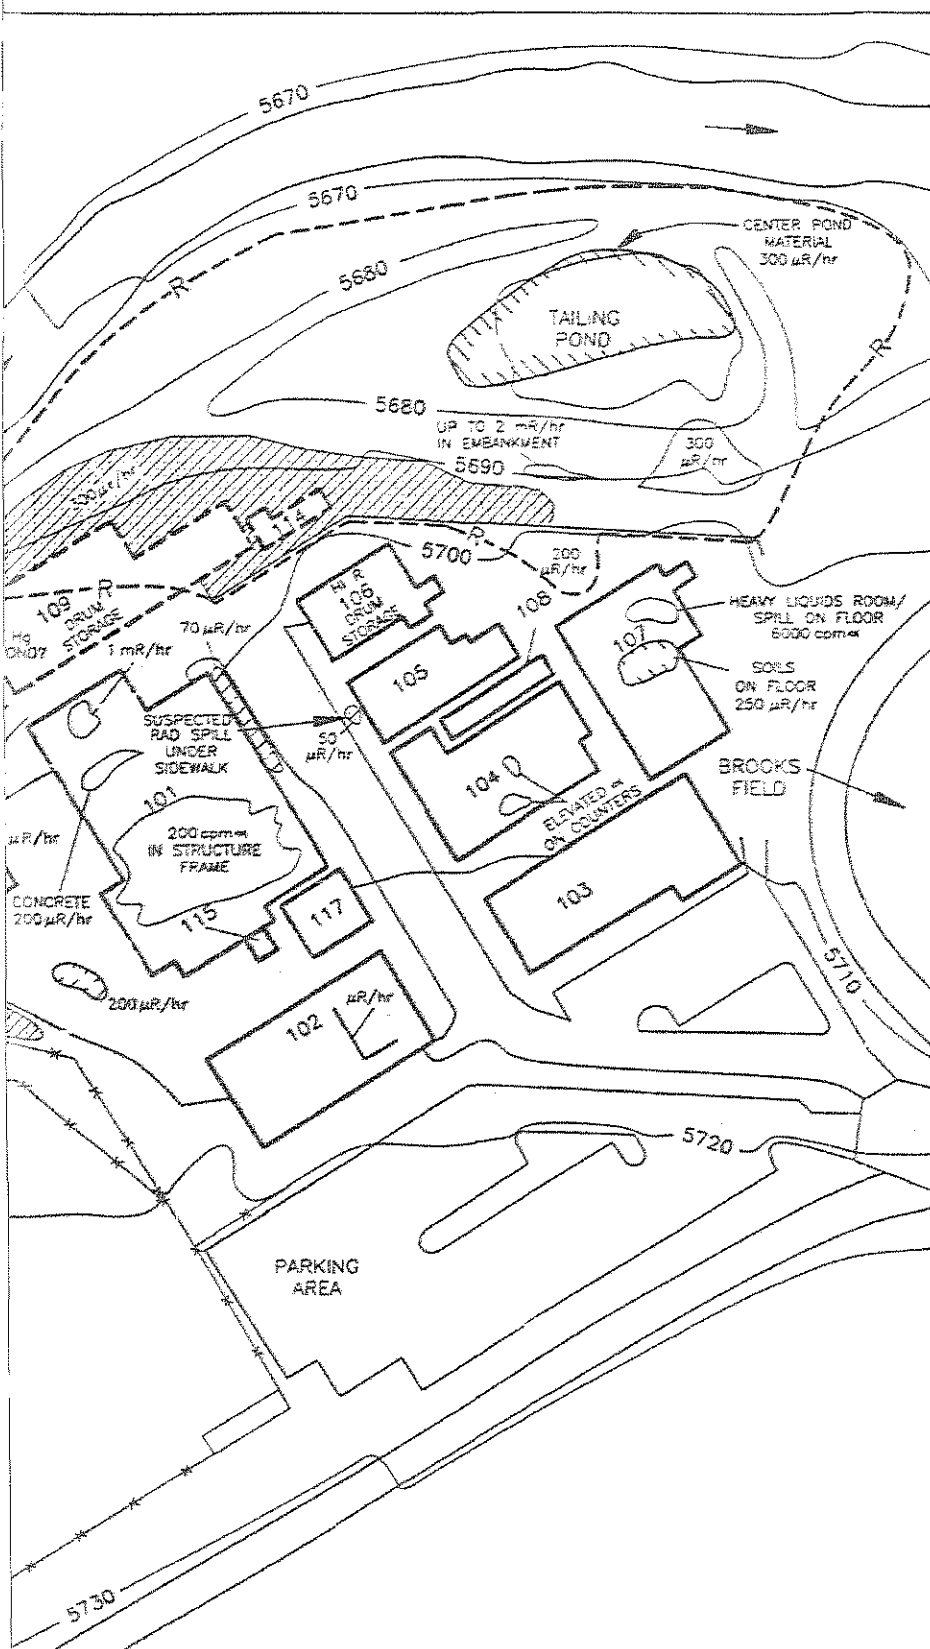
TITLE: CSMRI
Golden, Colorado
ZONES WITH ELEVATED RADIATION DATA FROM
JACOBS REPORT WITH MODIFICATIONS AS OF 05/92
T08-9202-017, T08-9205-018
T.D.D. T08-9210-011, T08-9210-012

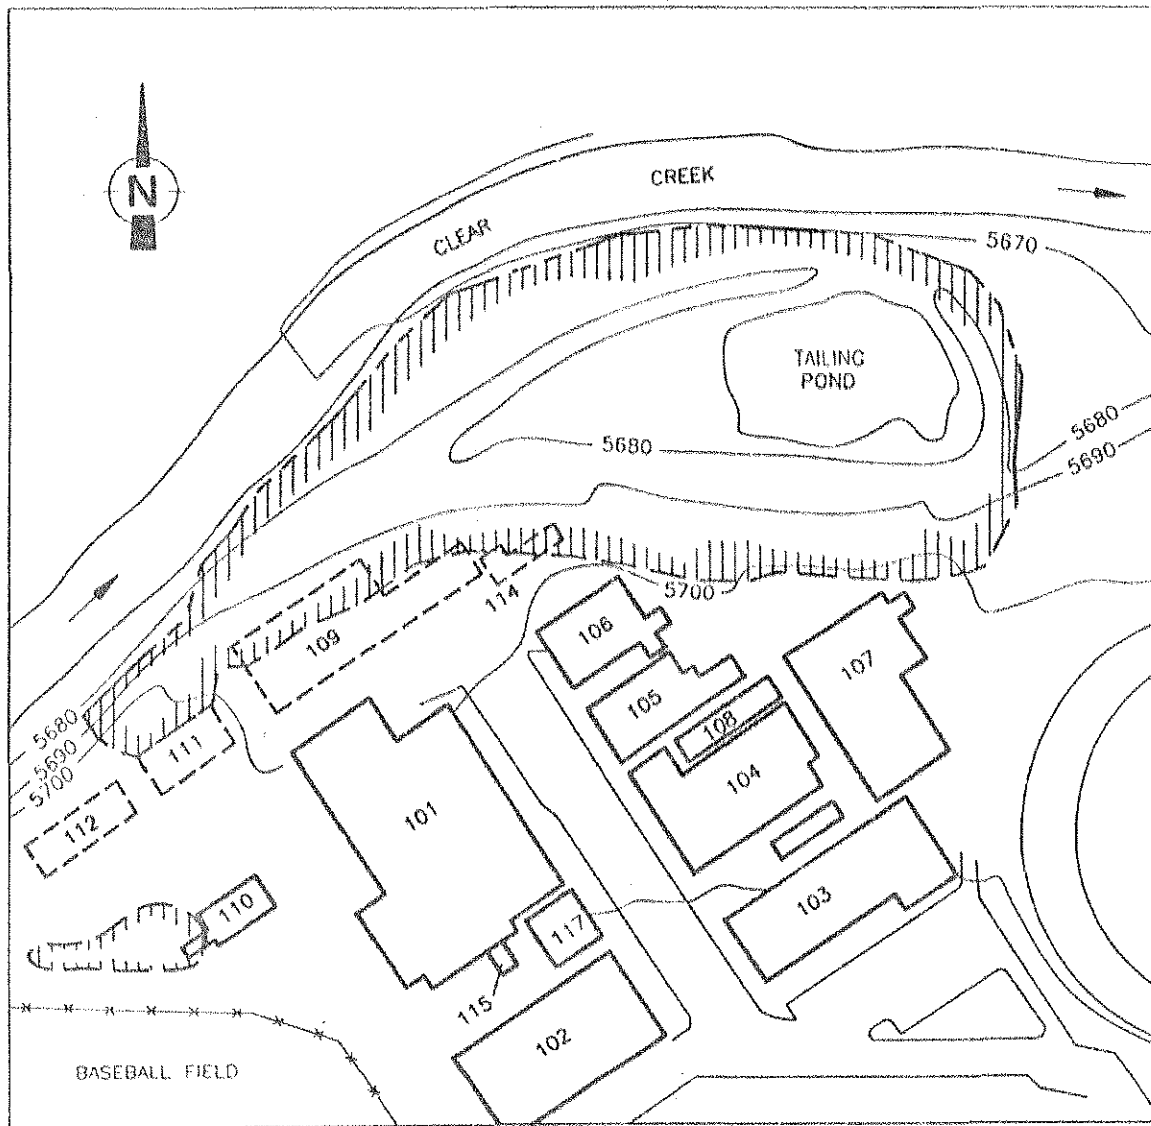
TECHNICAL ASSISTANCE TEAM FOR EMERGENCY RESPONSE, REMOVAL AND PREVENTION EPA CONTRACT 68-WO-0037	
TITLE: CSMRI Golden, Colorado ESTIMATED SOIL REMOVAL AREAS AS OF 6/1/92 T08-9202-017, T08-9205-018 T.D.D. T08-9210-011, T08-9210-012	
ecology & environment, inc. DENVER, COLORADO	FIG. 6
Date: 03/93 Drawn by: RSM Scale: _____

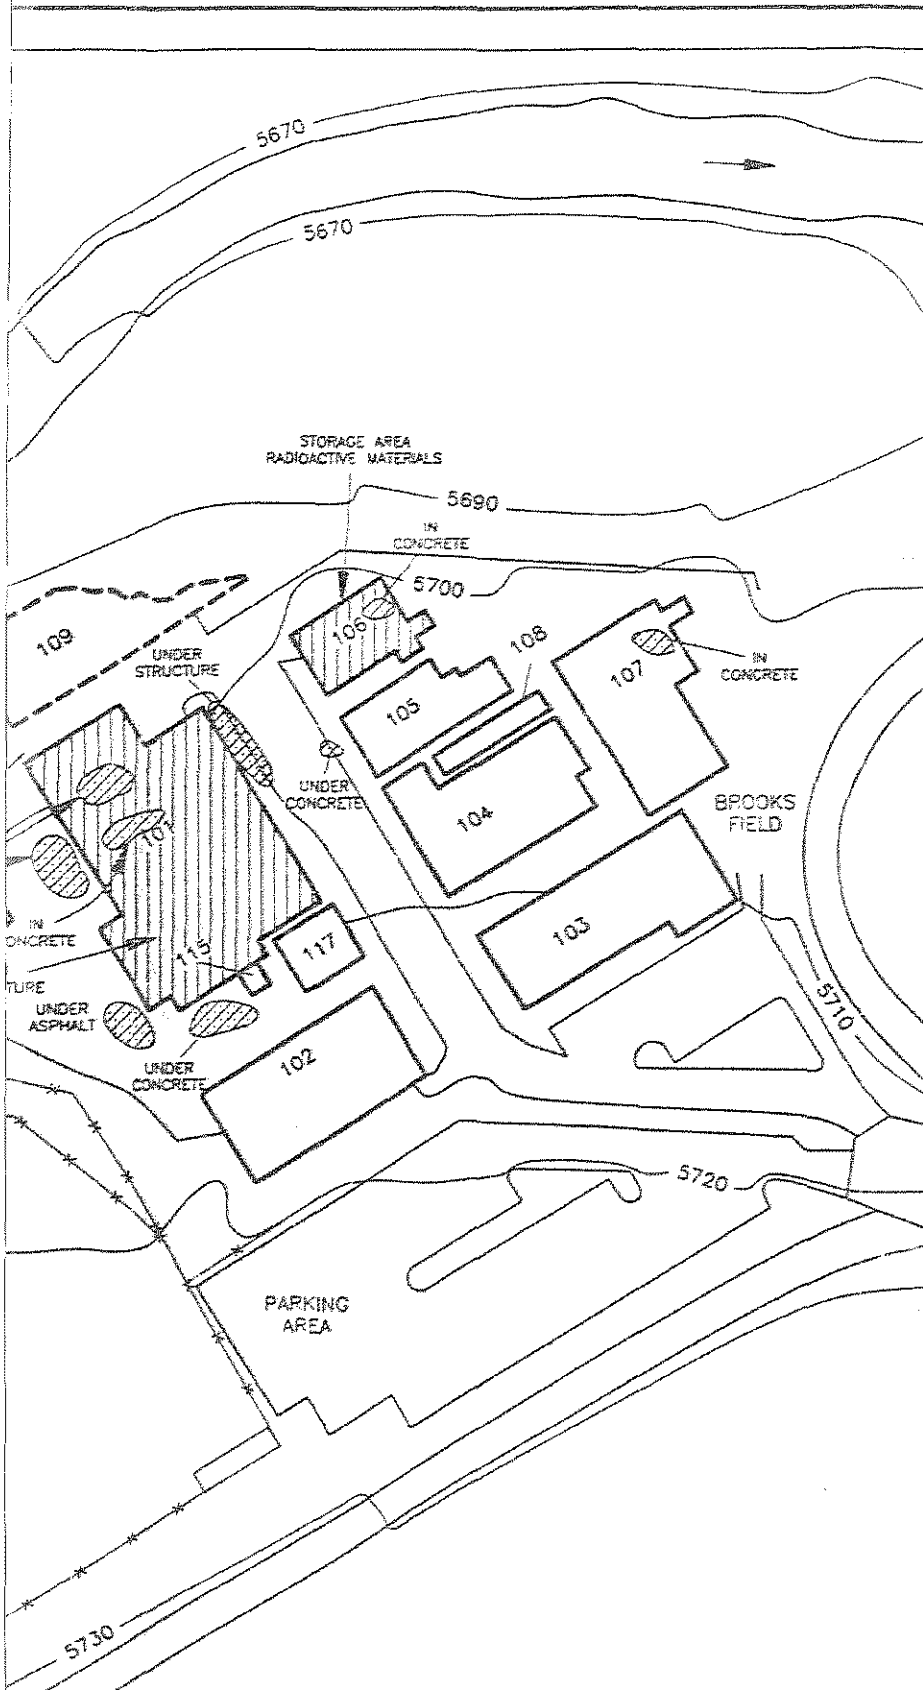
Immobile radioactive hazard area
-

TITLE: CSMRI
Golden, Colorado
REMAINING IMMOBILE RADIOACTIVE HAZARDS
T08-9202-017, T08-9205-018
T.D.D. T08-9210-011, T08-9210-012
