New Horizons Environmental Consultants, Inc. 6585 South Wright Street Littleton, CO 80127-4806	
	Project: CSMRI Remedial Investigation	Date: October 15, 2003
Project Number: 2112	Figure 4-6 Surface Soil Samples Ra-226 Activities

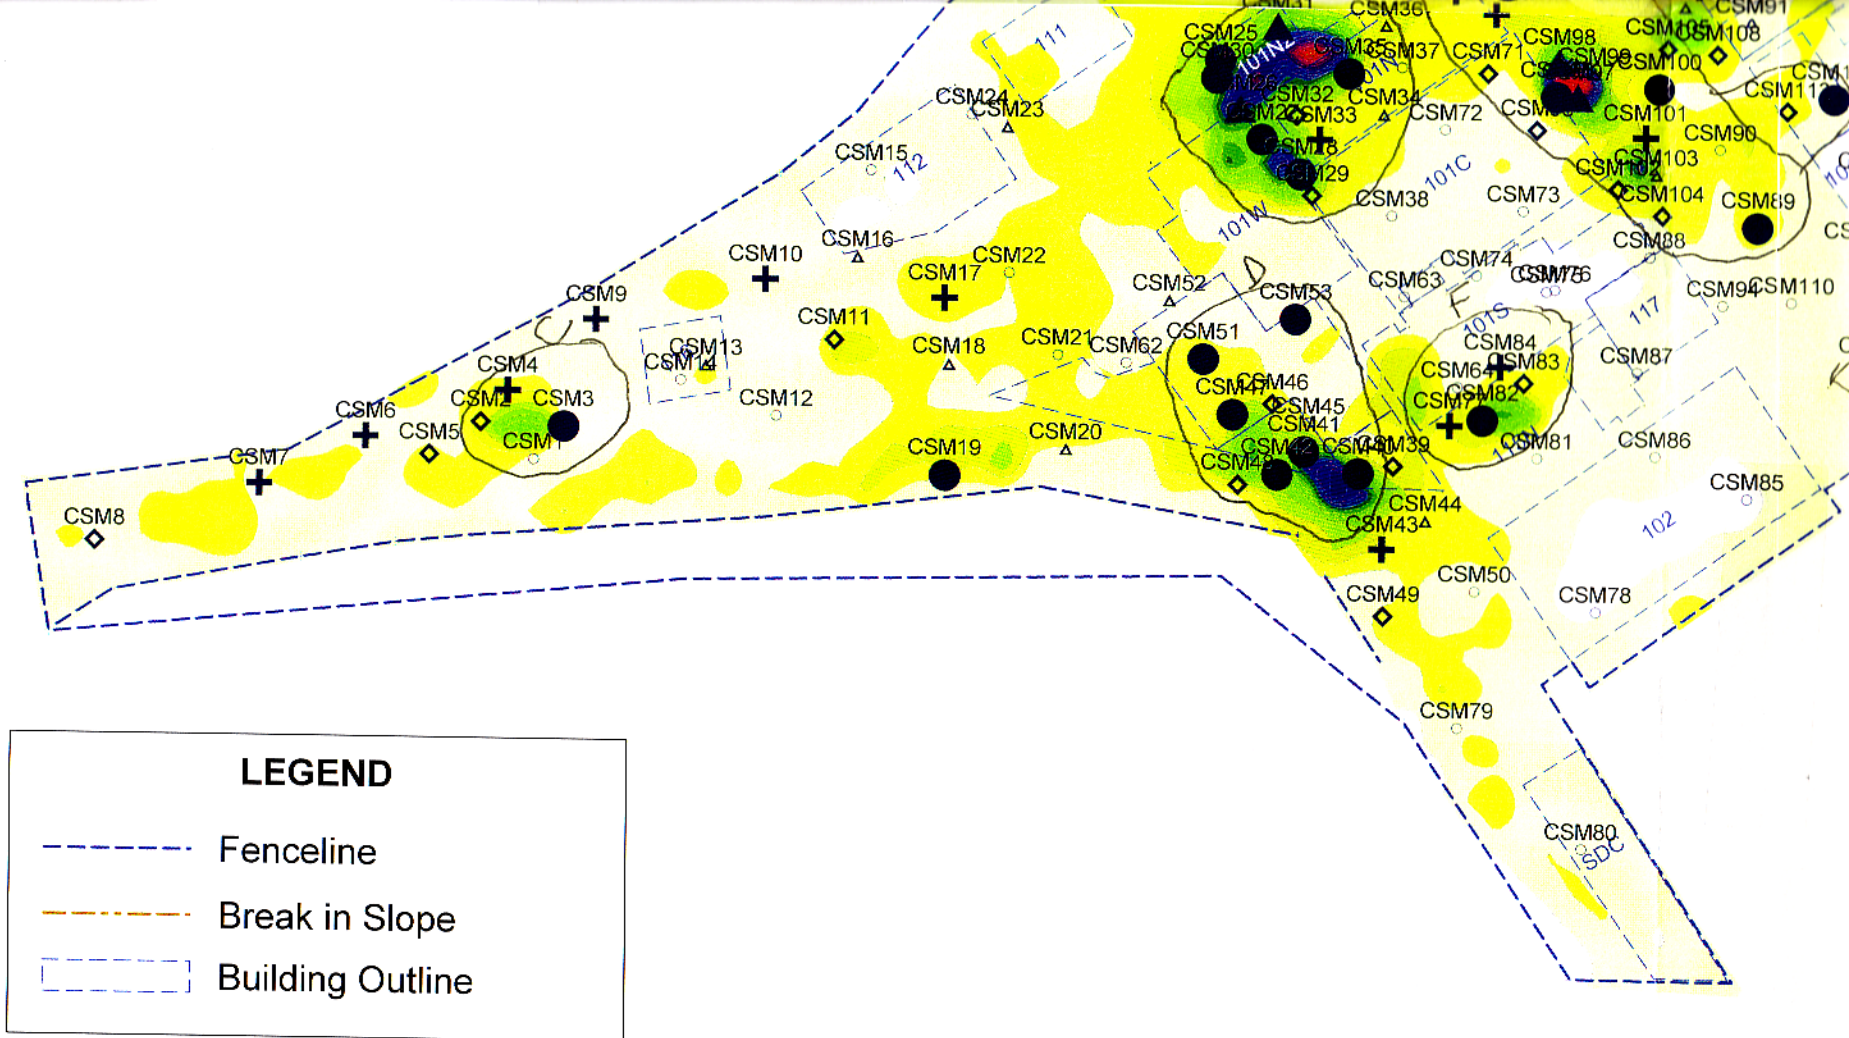
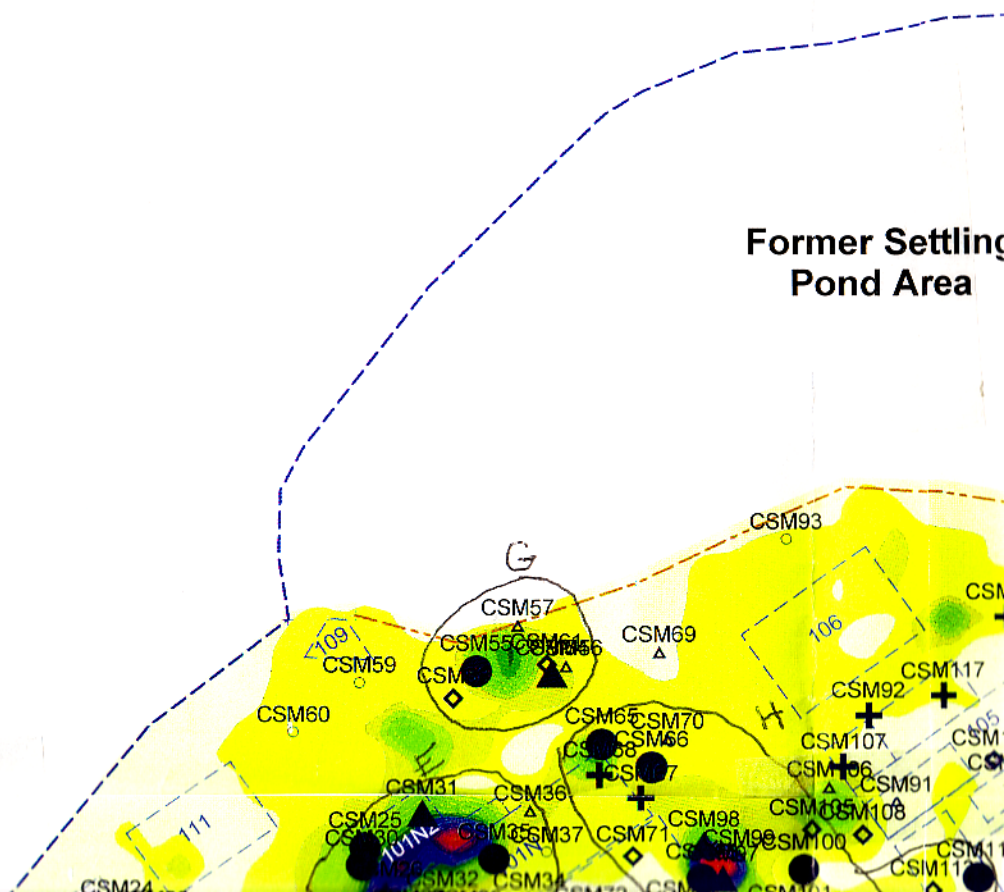
**Figure 4-6
Surface Soil Sample
Ra-226 Activities**

Note: Background color variations represent surface gamma distribution generated by geostatistics (kriging).
