Figure 4-1
CSMRI Surface Survey Gamma Radiation Distribution
Represented by Block Kriging with Linear Drift

New Horizons Environmental Consultants, Inc. 6585 South Wright Street Littleton, CO 80127-4806		
		Project: CSMRI Remedial Investigation
Project Number: 2112	Figure 4-1 CSMRI Surface Survey Gamma Distribution Represented by Block Kriging with Linear Drift

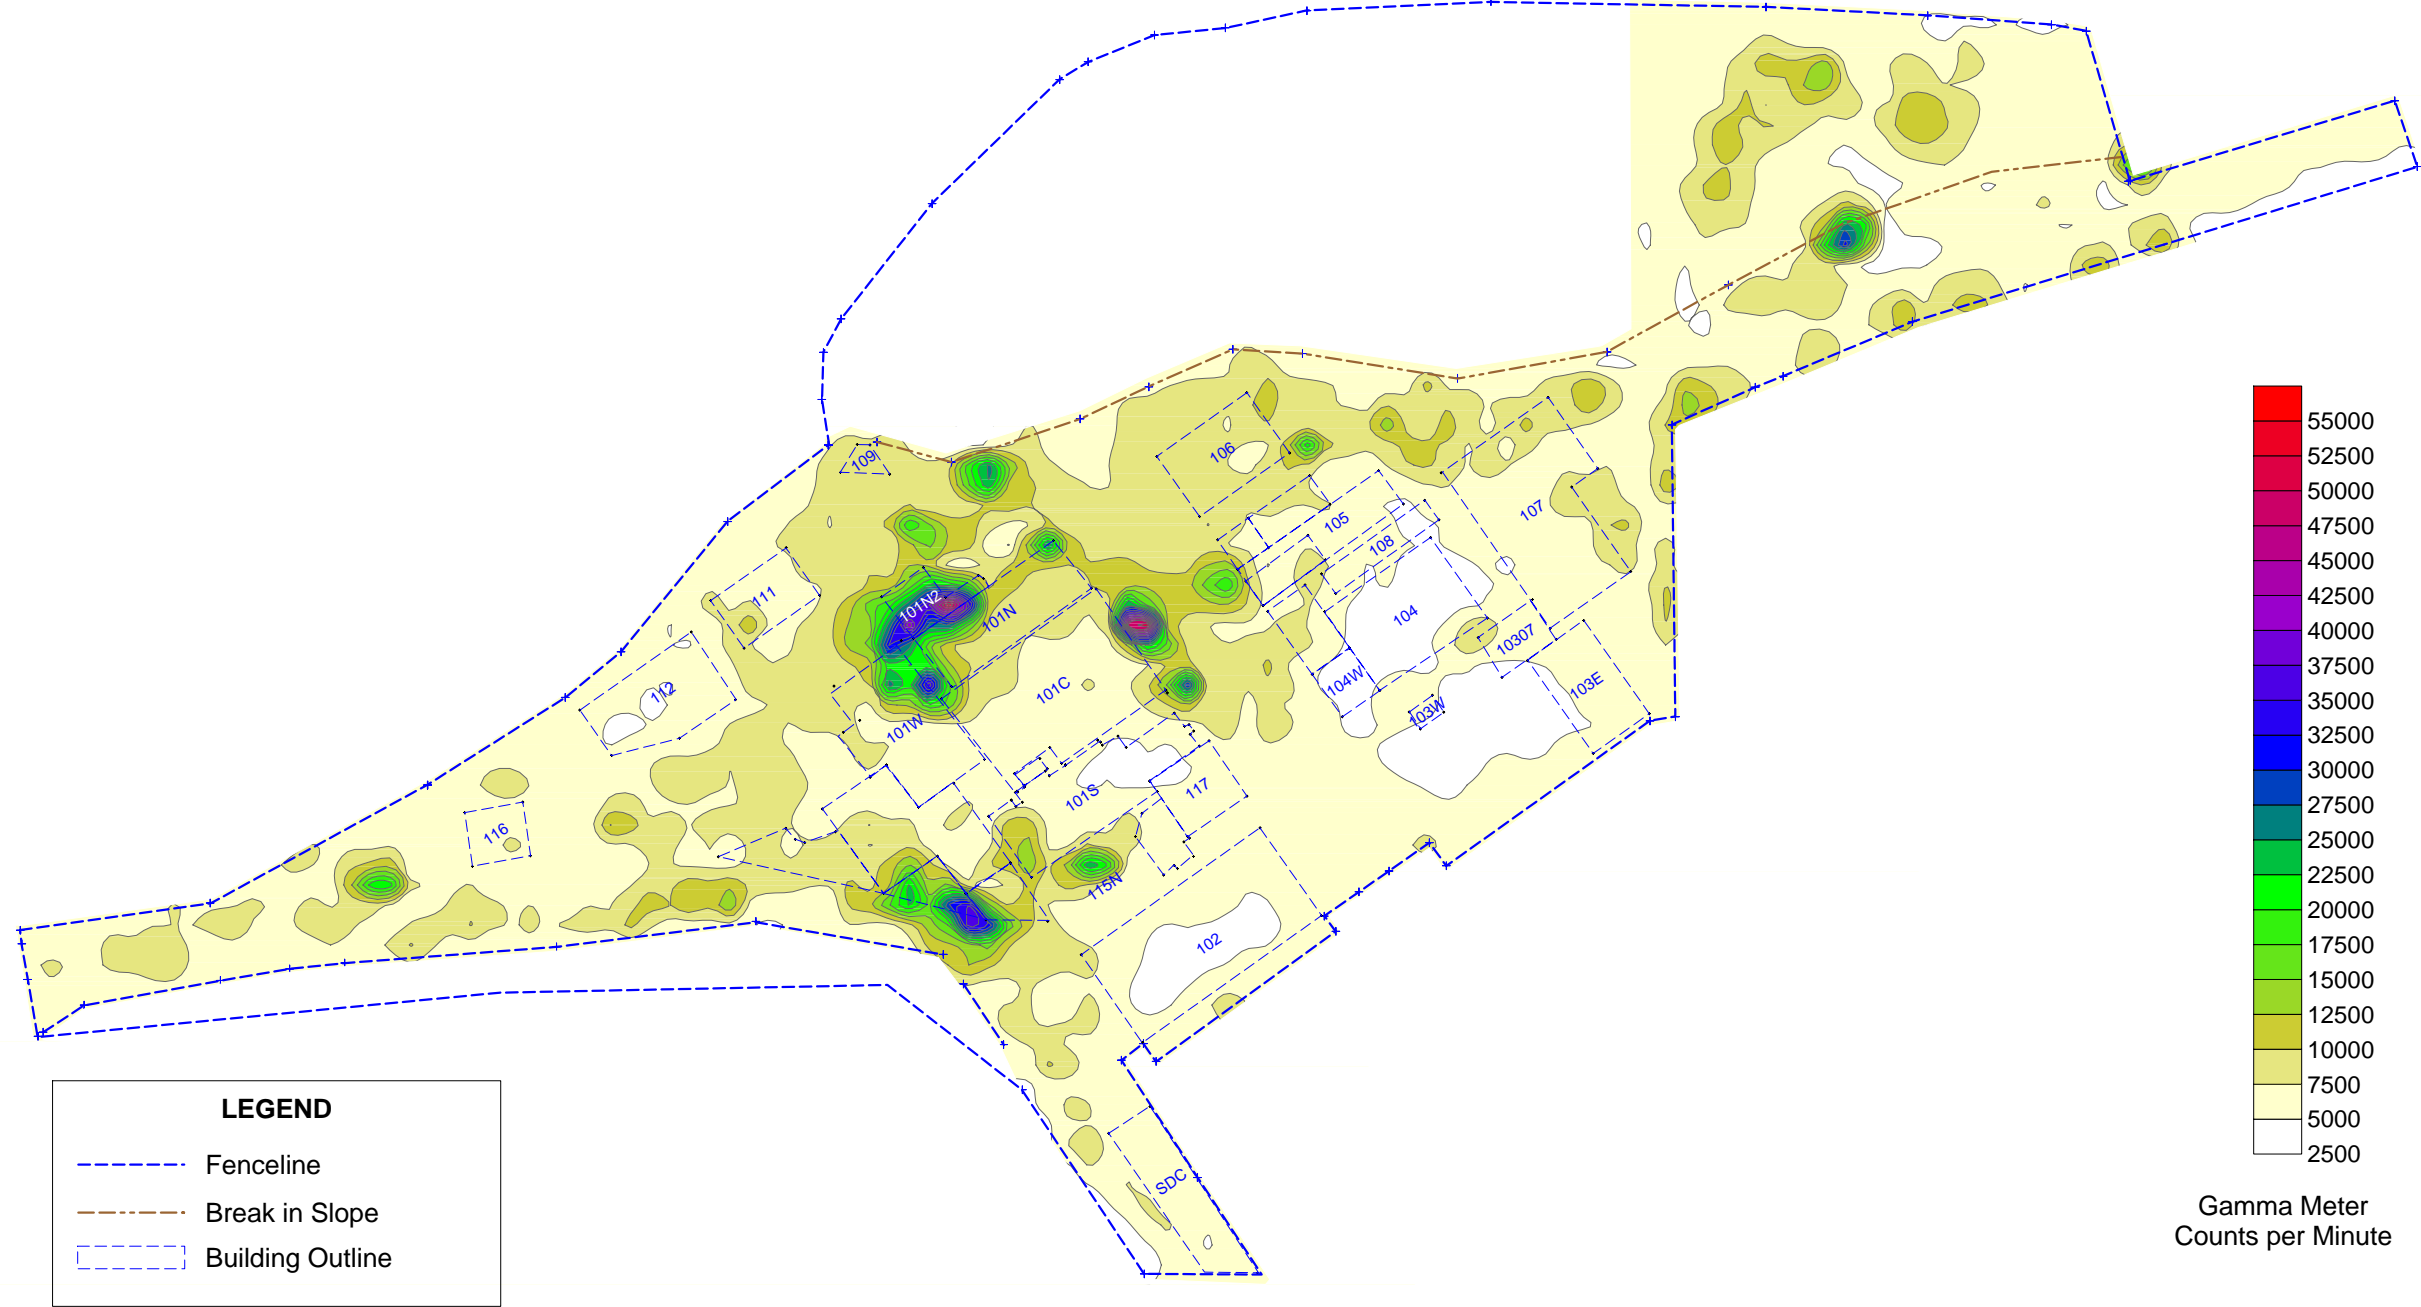
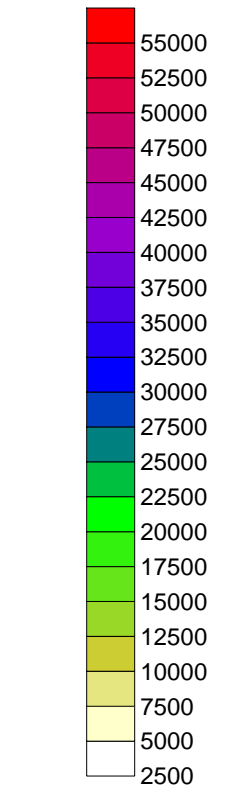
Gamma Meter
Counts per Minute
