Project: CSMRI Remedial Investigation

Figure 4-2 CSMRI Surface Soil Samples Arsenic Concentrations

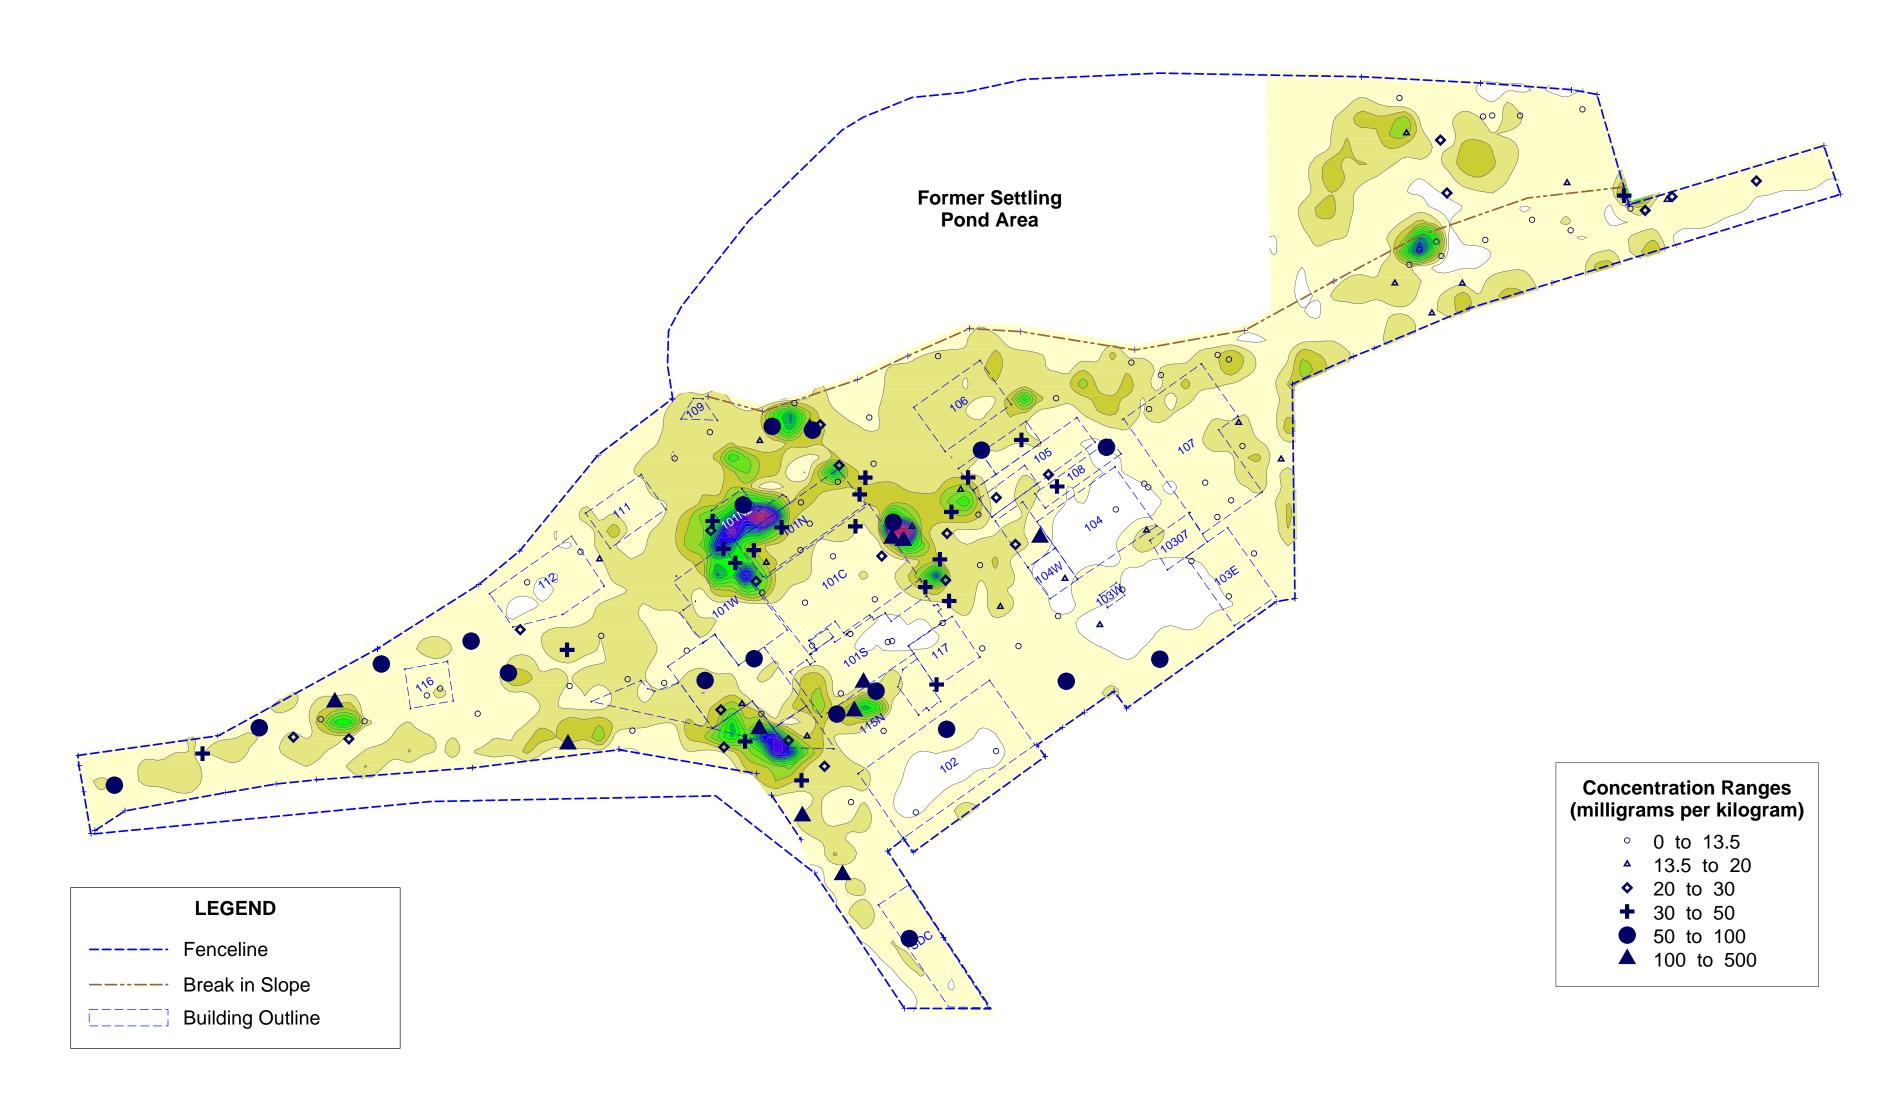
Figure 4-2
CSMRI Surface Soil Samples
Arsenic Concentrations

Note: Background color variations represent surface gamma distribution generated by geostatistics (kriging).
