VOLUME 1
SUMMARY REPORT ON SITE INVESTIGATION
AND REMOVAL ACTIVITIES
CSMRI CREEKSIDE SITE
GOLDEN, JEFFERSON COUNTY, COLORADO
TDDS T08-9202-017, T08-9205-018
T08-9210-011, T08-9210-012

Michael J. Sullivan
Ecology & Environment, Inc.
Technical Assistance Team

DATE SUBMITTED: March 17, 1993

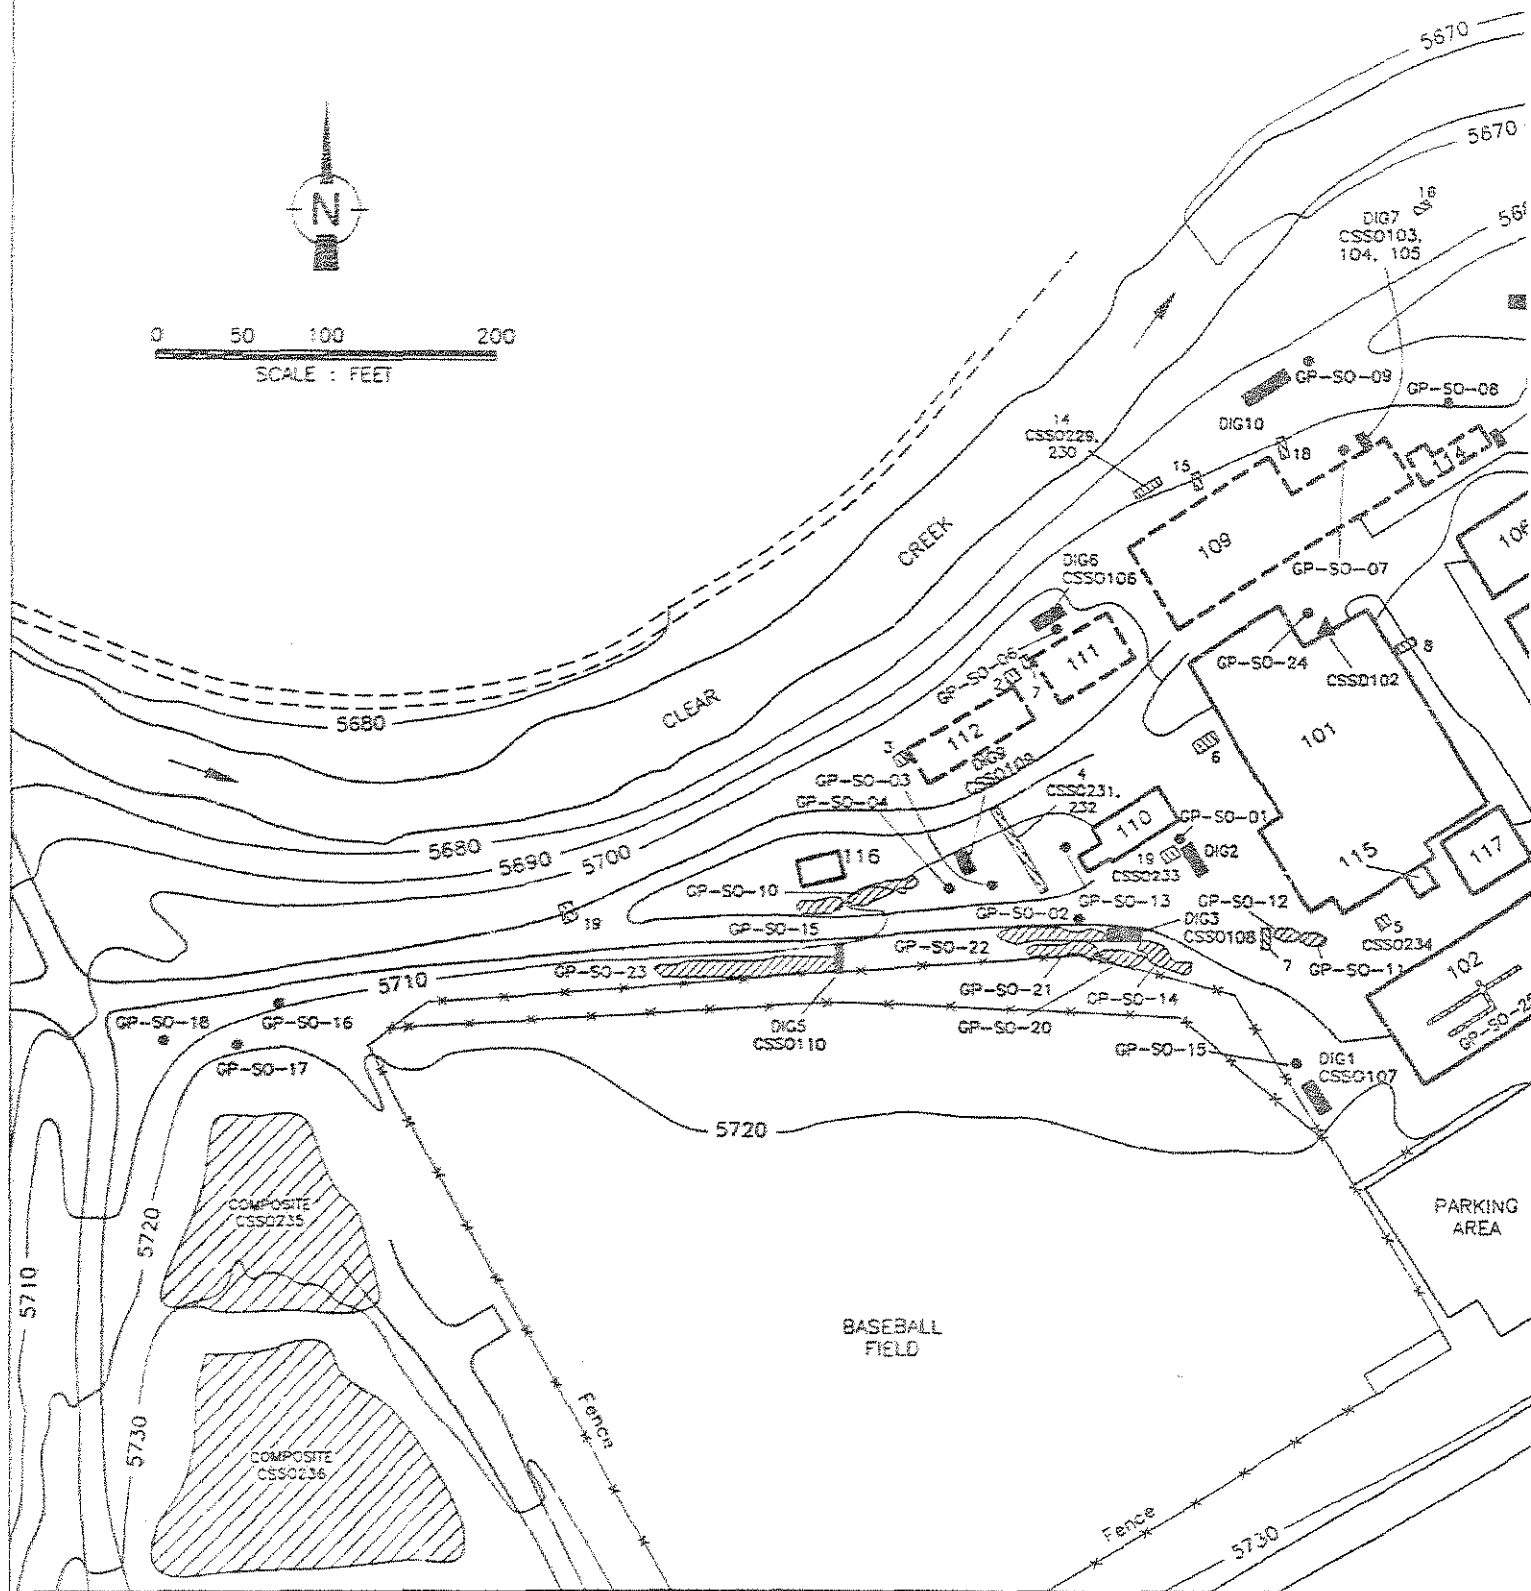
TITLE: CSMRI
Golden, Colorado
REMAINING IMMOBILE RADIOACTIVE HAZARDS
T08-9202-017, T08-9205-018
T.D.D. T08-9210-011, T08-9210-012

Immobile radioactive hazard area
-

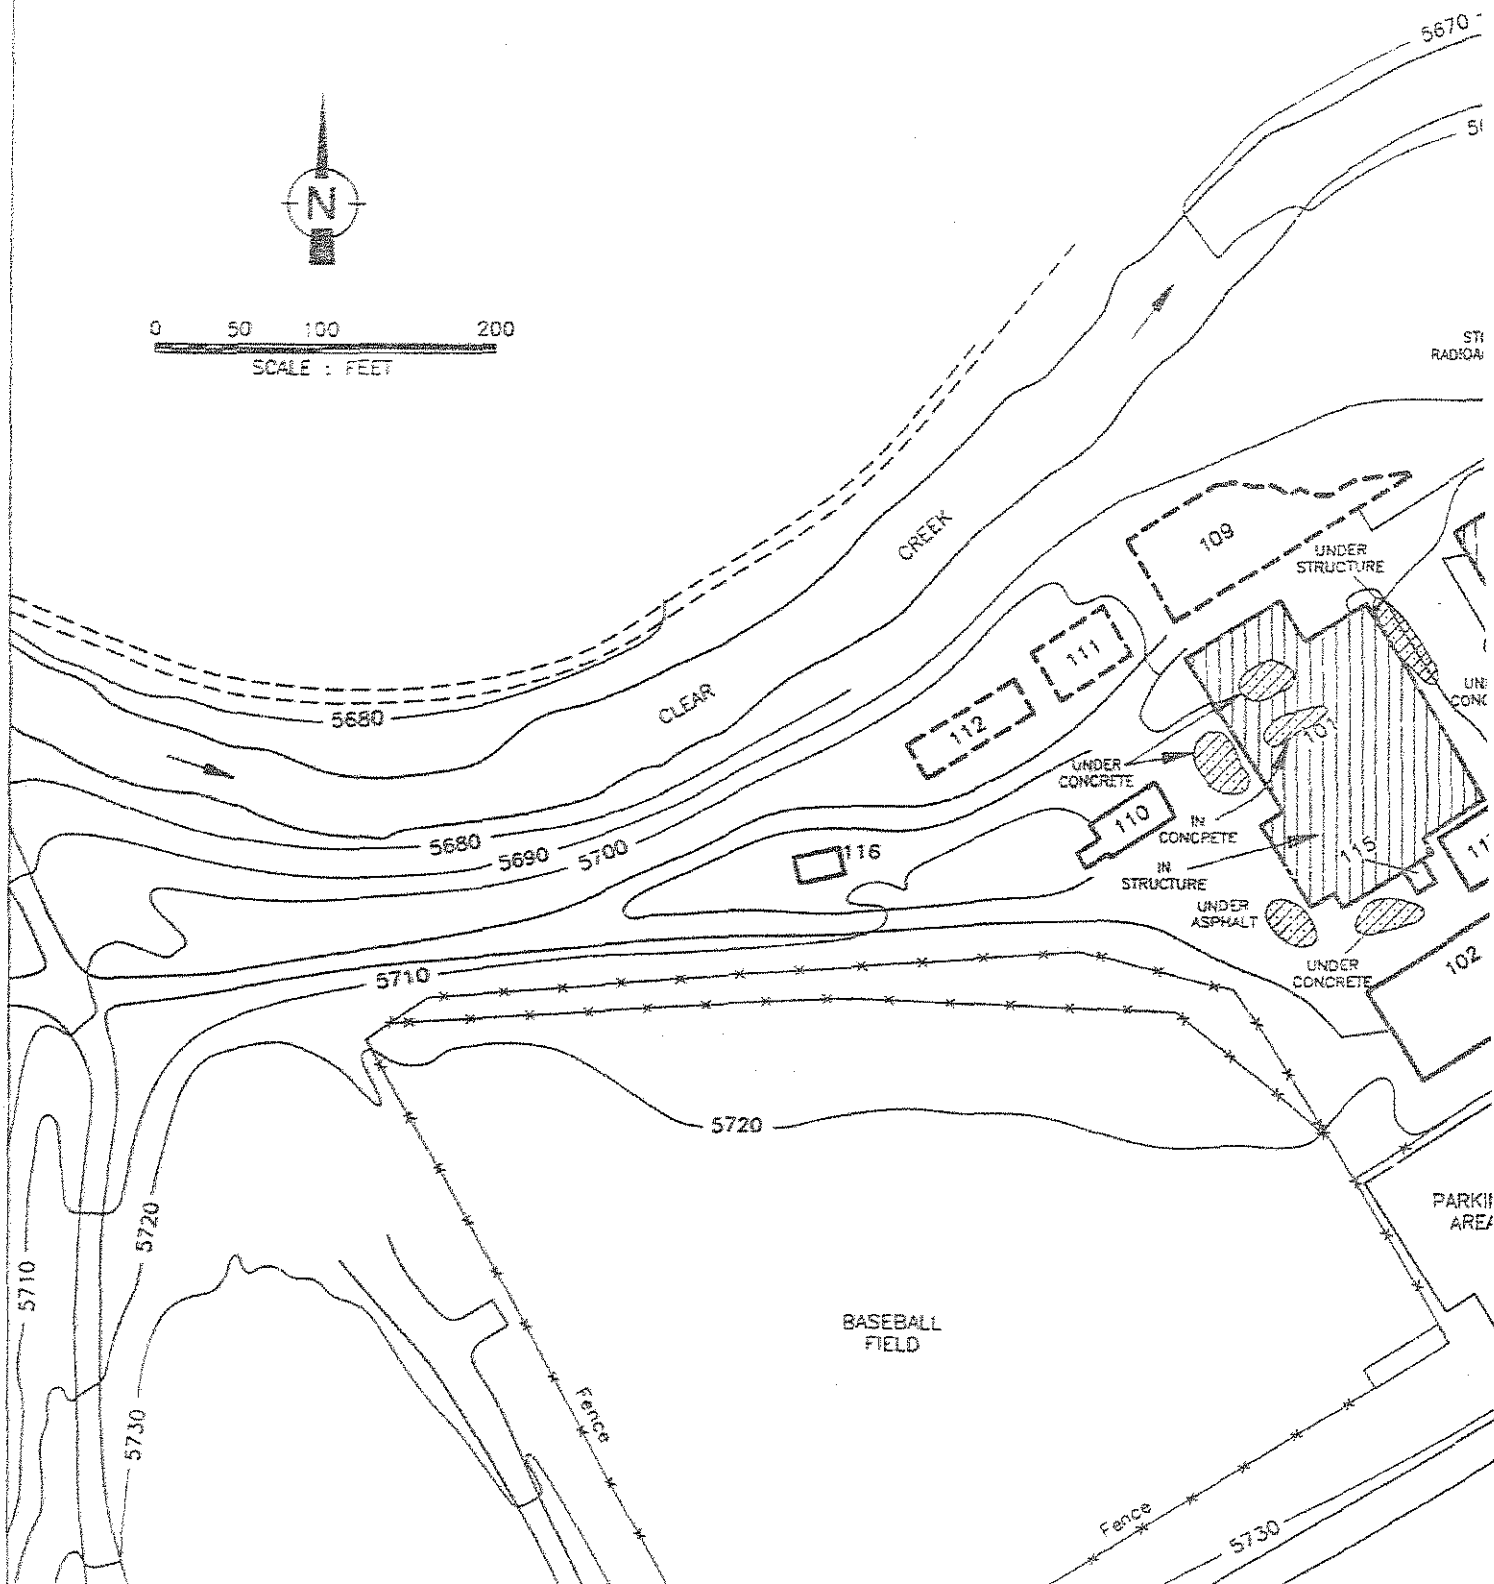
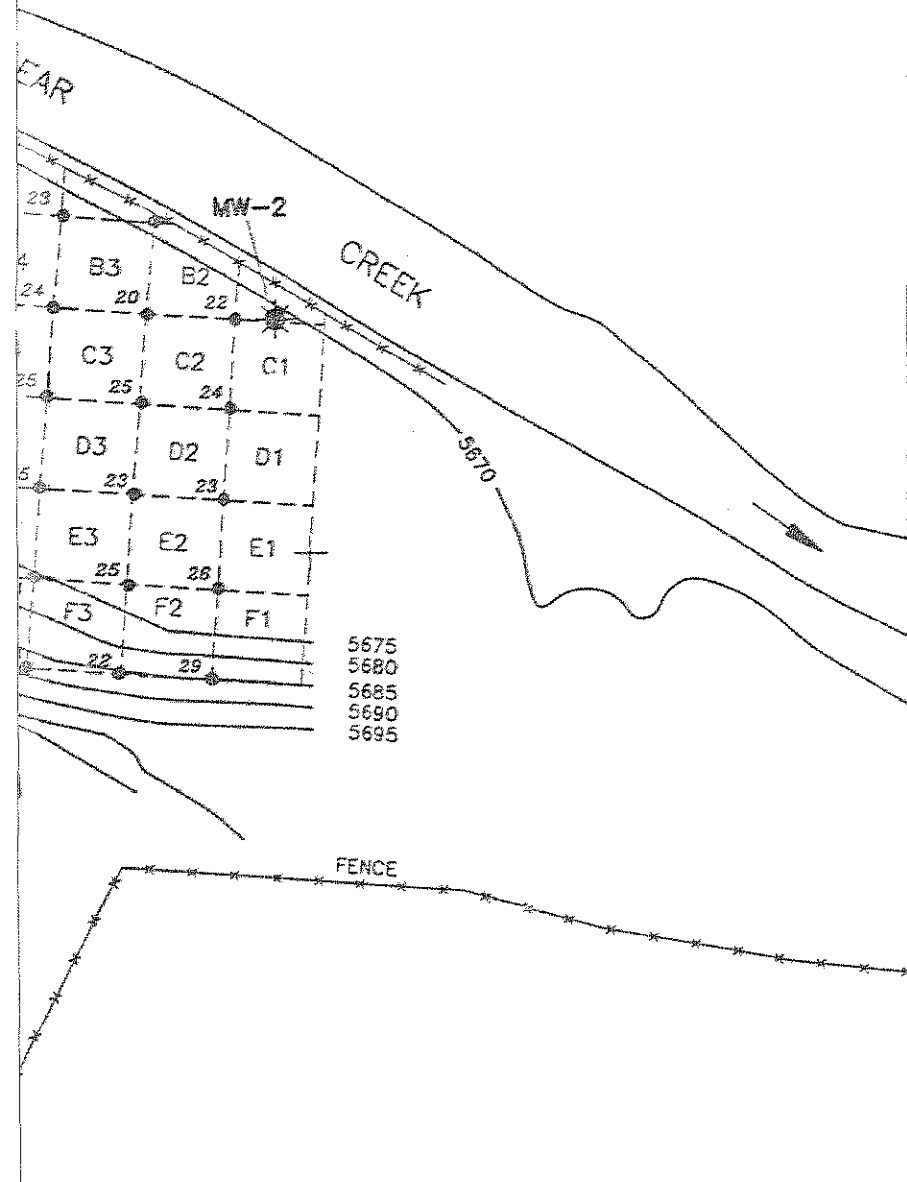
FIG. 8

Removal confirmation sampling was performed in the tailings pond and embankment after removal operations were completed. Confirmation included constructing a 10m x 10m grid and taking composite samples from each grid. Each soil sample was sent to REAC for analysis by gamma spectral analysis. Results indicated that all samples had concentrations of less than 15 pCi/gm, the limit prescribed by the Nuclear Regulatory Commission (NRC) for soils below six inches of cover. Selected samples were also collected for metals analysis. The sampled area is depicted in Figure 8. The results of analysis are presented in Table 3.

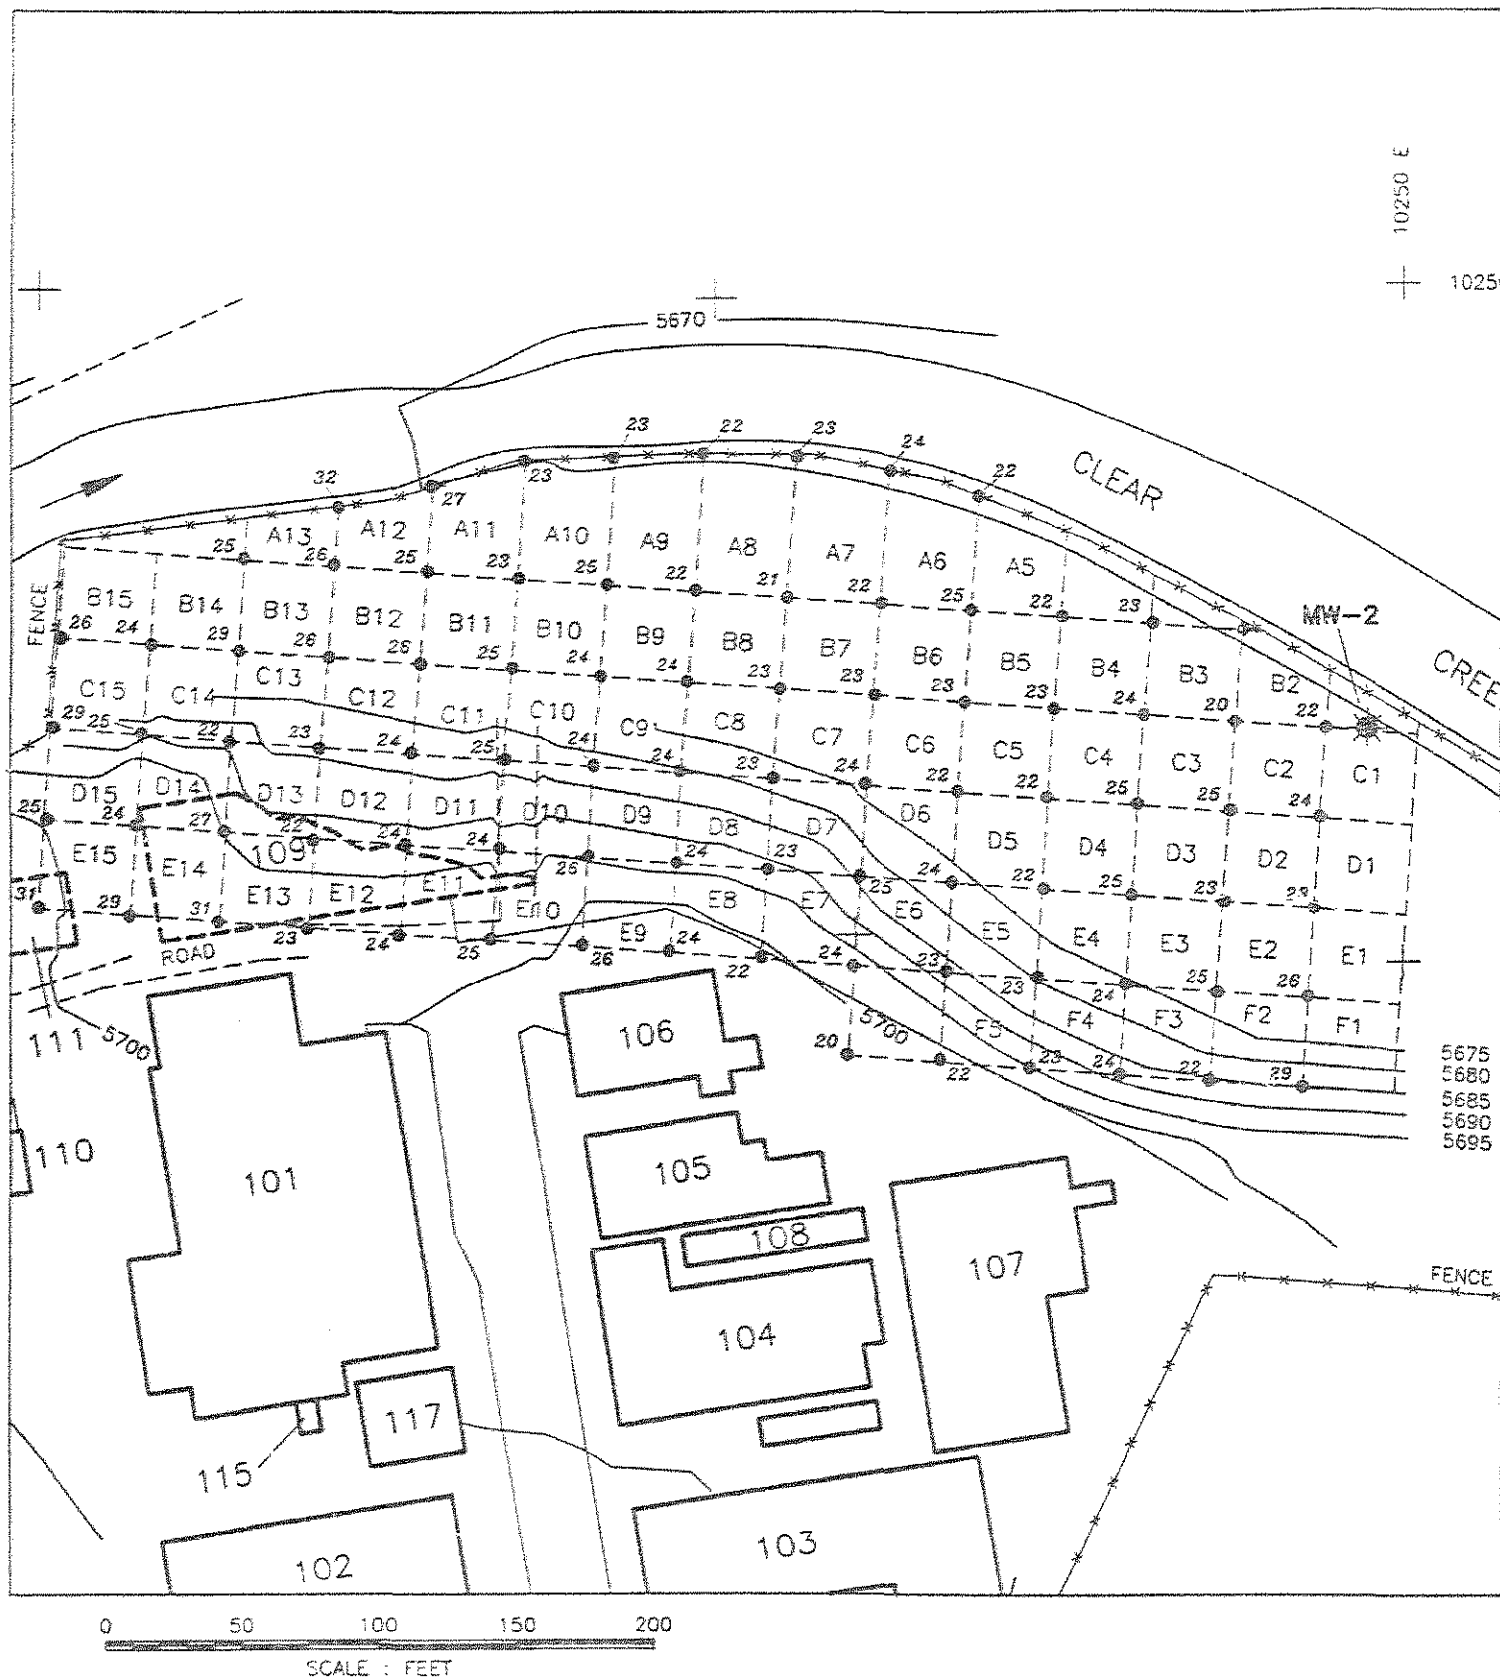
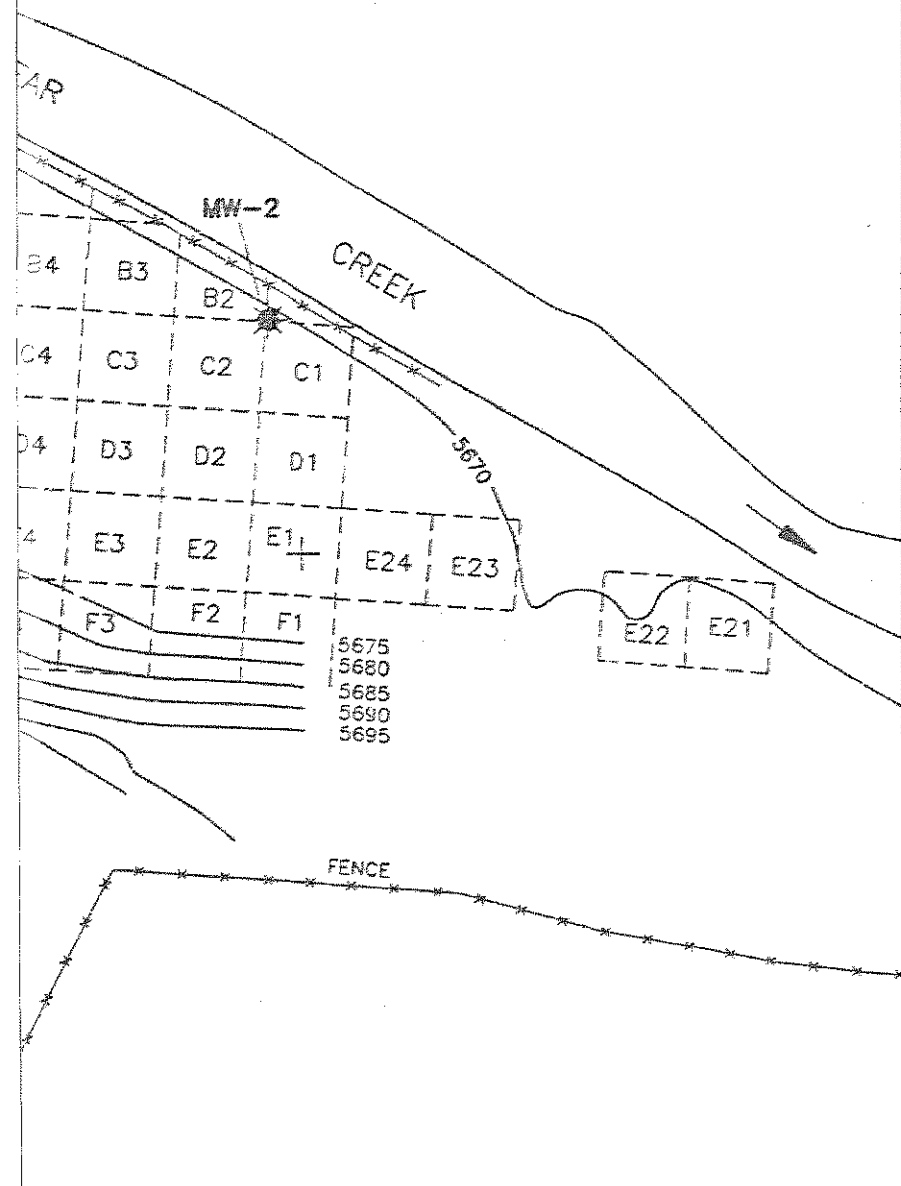
FIG. 9

After placement of fill and topsoil in the removal area, the Colorado Department of Health requested that the area be sampled to assure conformance with the NRC limits on soil contamination. The area was again gridded in a 10 meter grid and composite soil samples taken from each grid (Figure 9). Soil samples were again sent to REAC for analysis. All samples passed the 5 pCi/gm limit for surface soils as prescribed by NRC. The analytical data for the surface soil samples is presented in Table 4. A survey with the Ludlum Micro R survey meter was also performed. A reading was taken at each node point of the grid. The survey indicated that no areas above the 70 μ R/hr limit remained in the tailings pond area. Data for the survey are included in Figure 9.
