**Figure 4-11  
Test Pit Samples  
Variation of Concentration with Depth - Arsenic and Lead**

Project: CSMRI Remedial Investigation      Date: October 15, 2003

Project Number: 2112      Figure 4-11 Test Pit Samples - Variation of Concentration with Depth - Arsenic and Lead

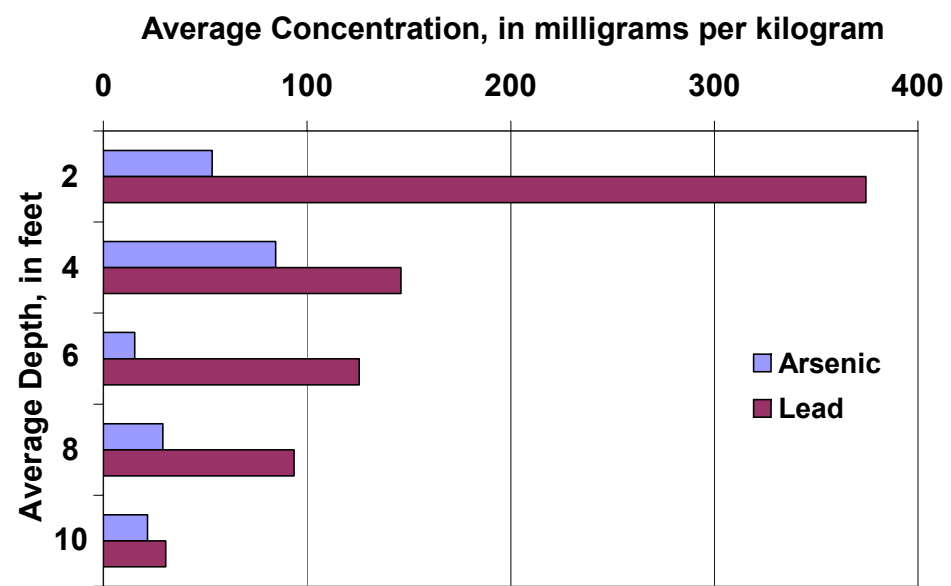
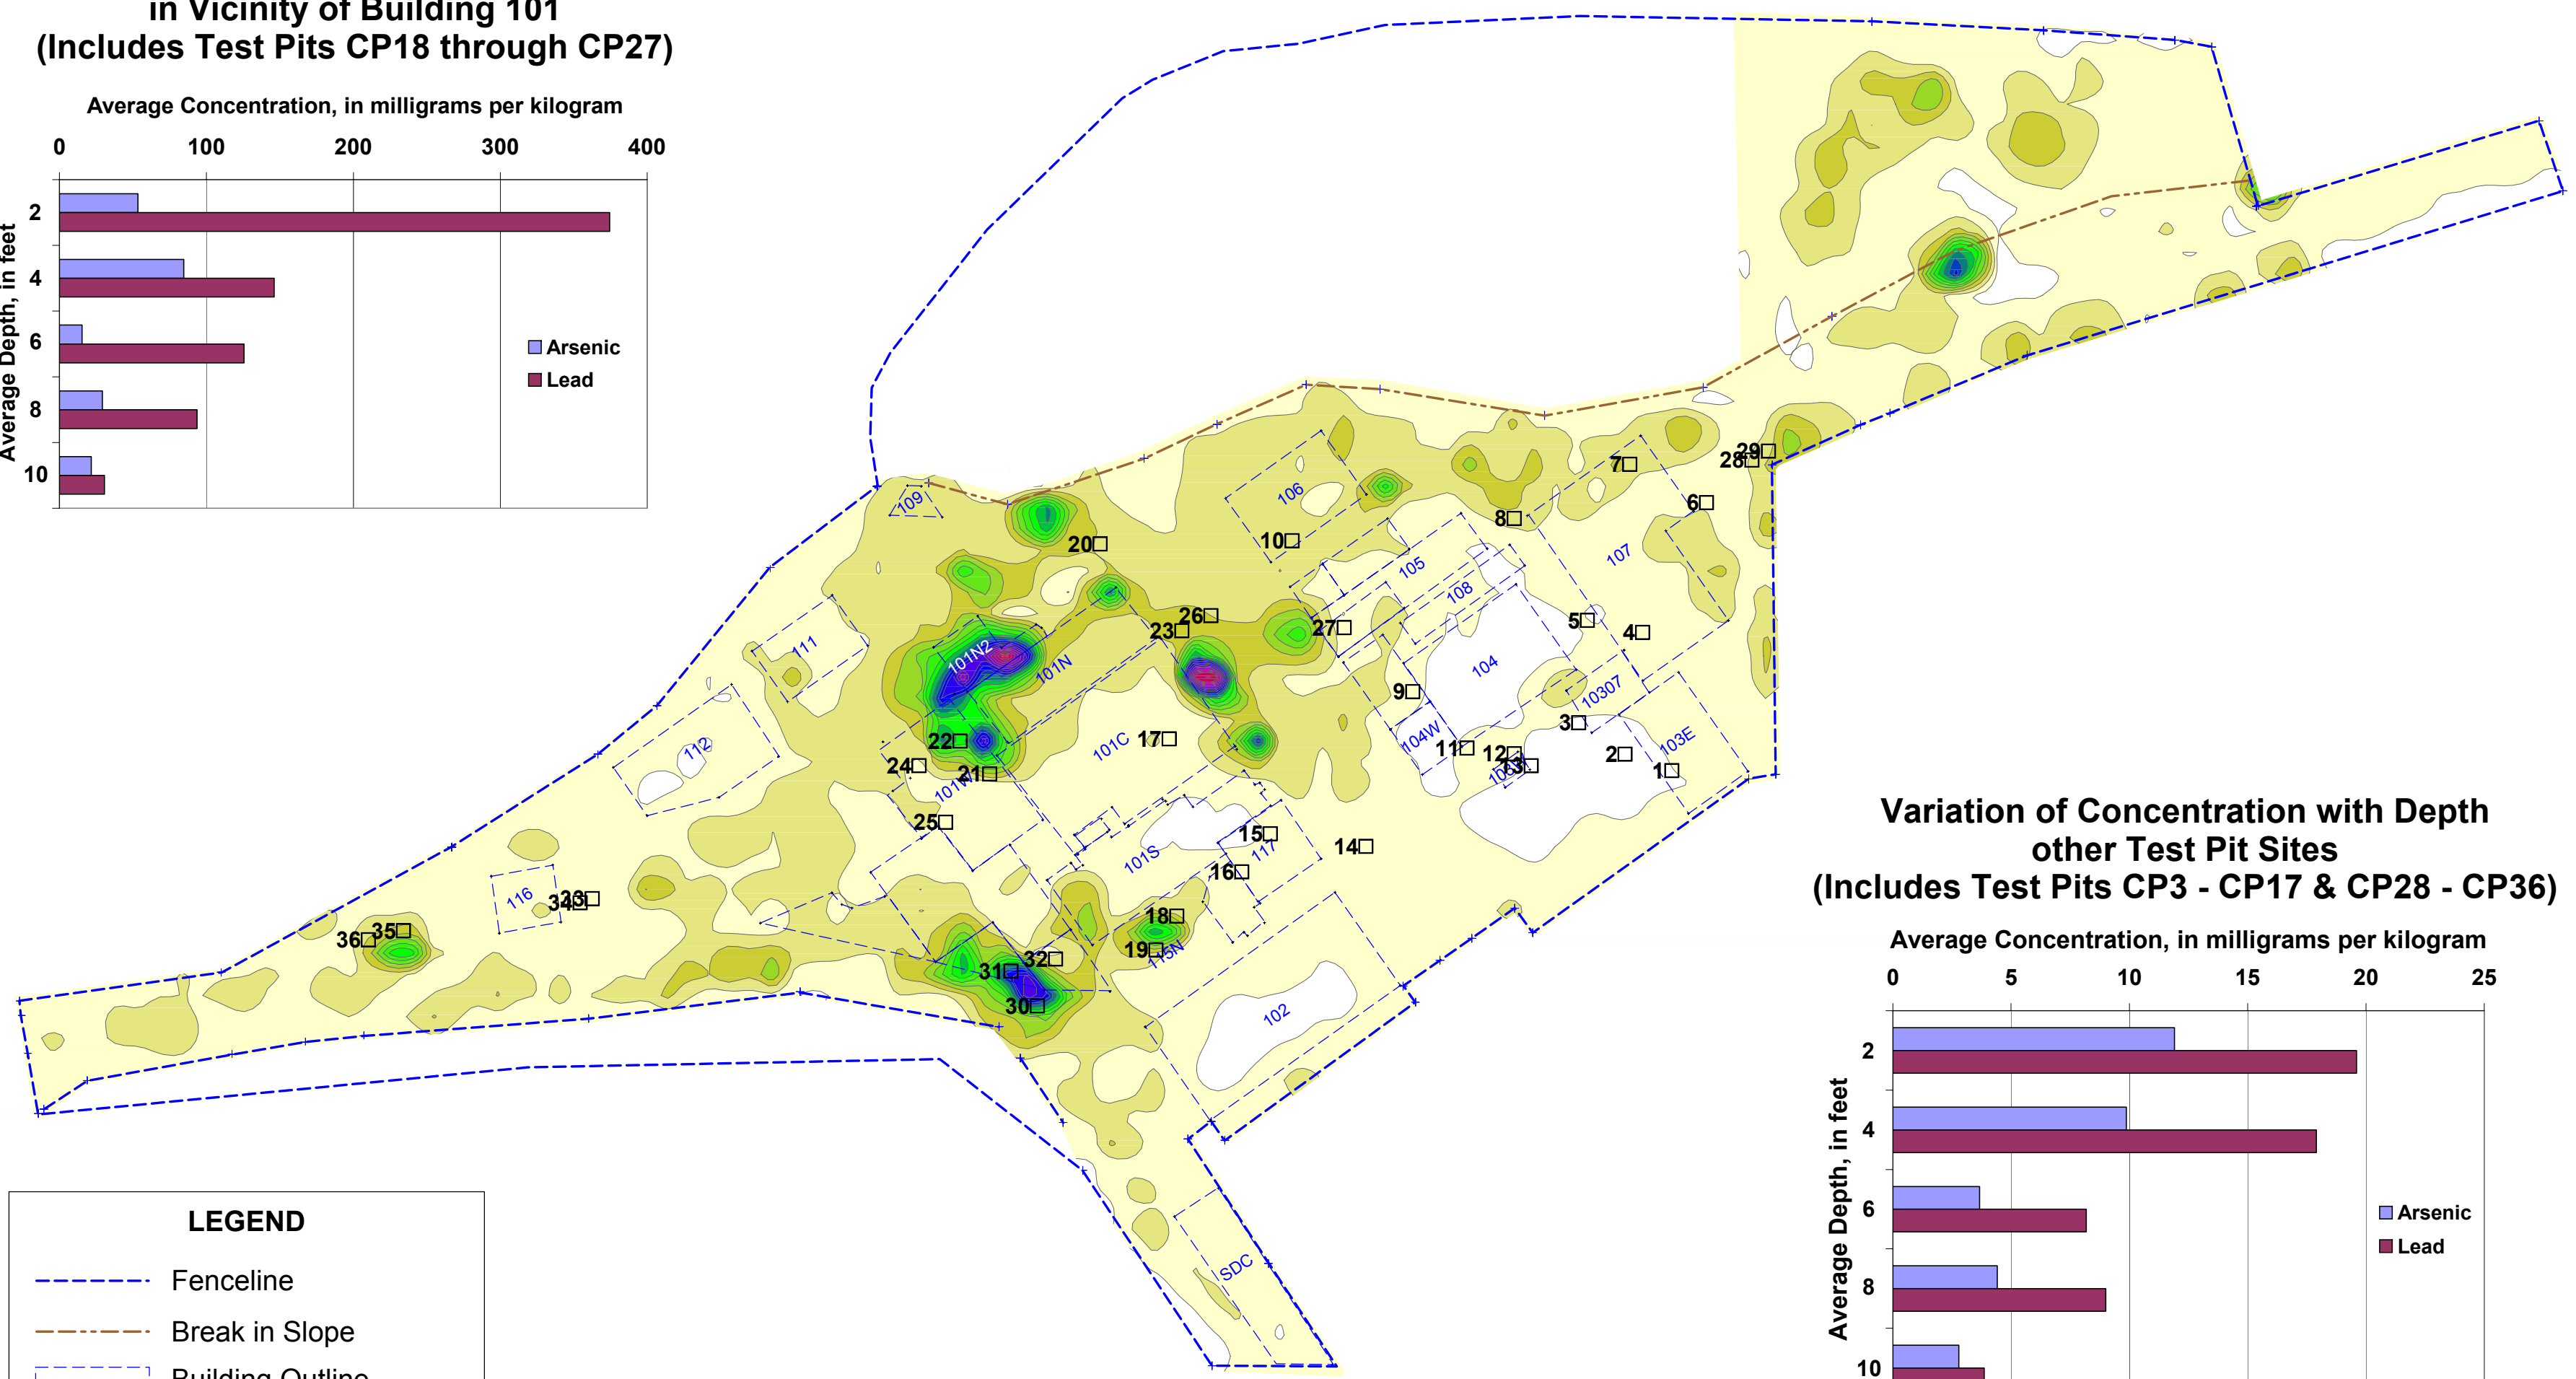
**Variation of Concentration with Depth  
in Vicinity of Building 101  
(Includes Test Pits CP18 through CP27)**

Notes: Lognormal distribution assumed for calculation of average concentration. Small sample sizes (<30) were used for calculations. Different scales used for graphs.

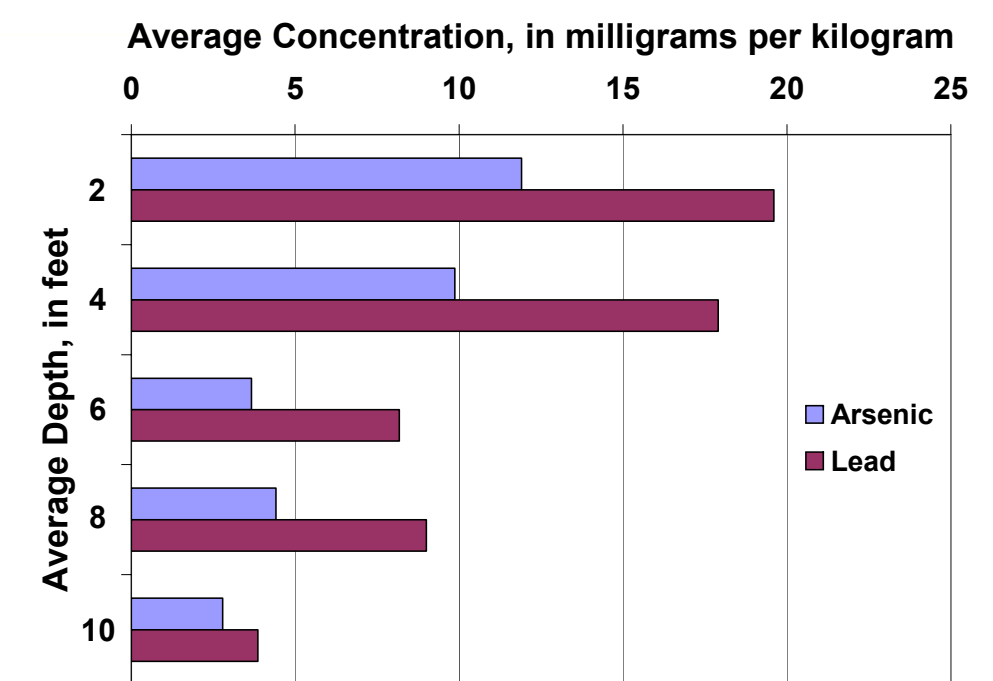
**Variation of Concentration with Depth  
other Test Pit Sites  
(Includes Test Pits CP3 - CP17 & CP28 - CP36)**
