Figure 4-4
CSMRI Surface Soil Samples
Lead Concentrations

Project: CSMRI Remedial Investigation

Date: October 15, 2003

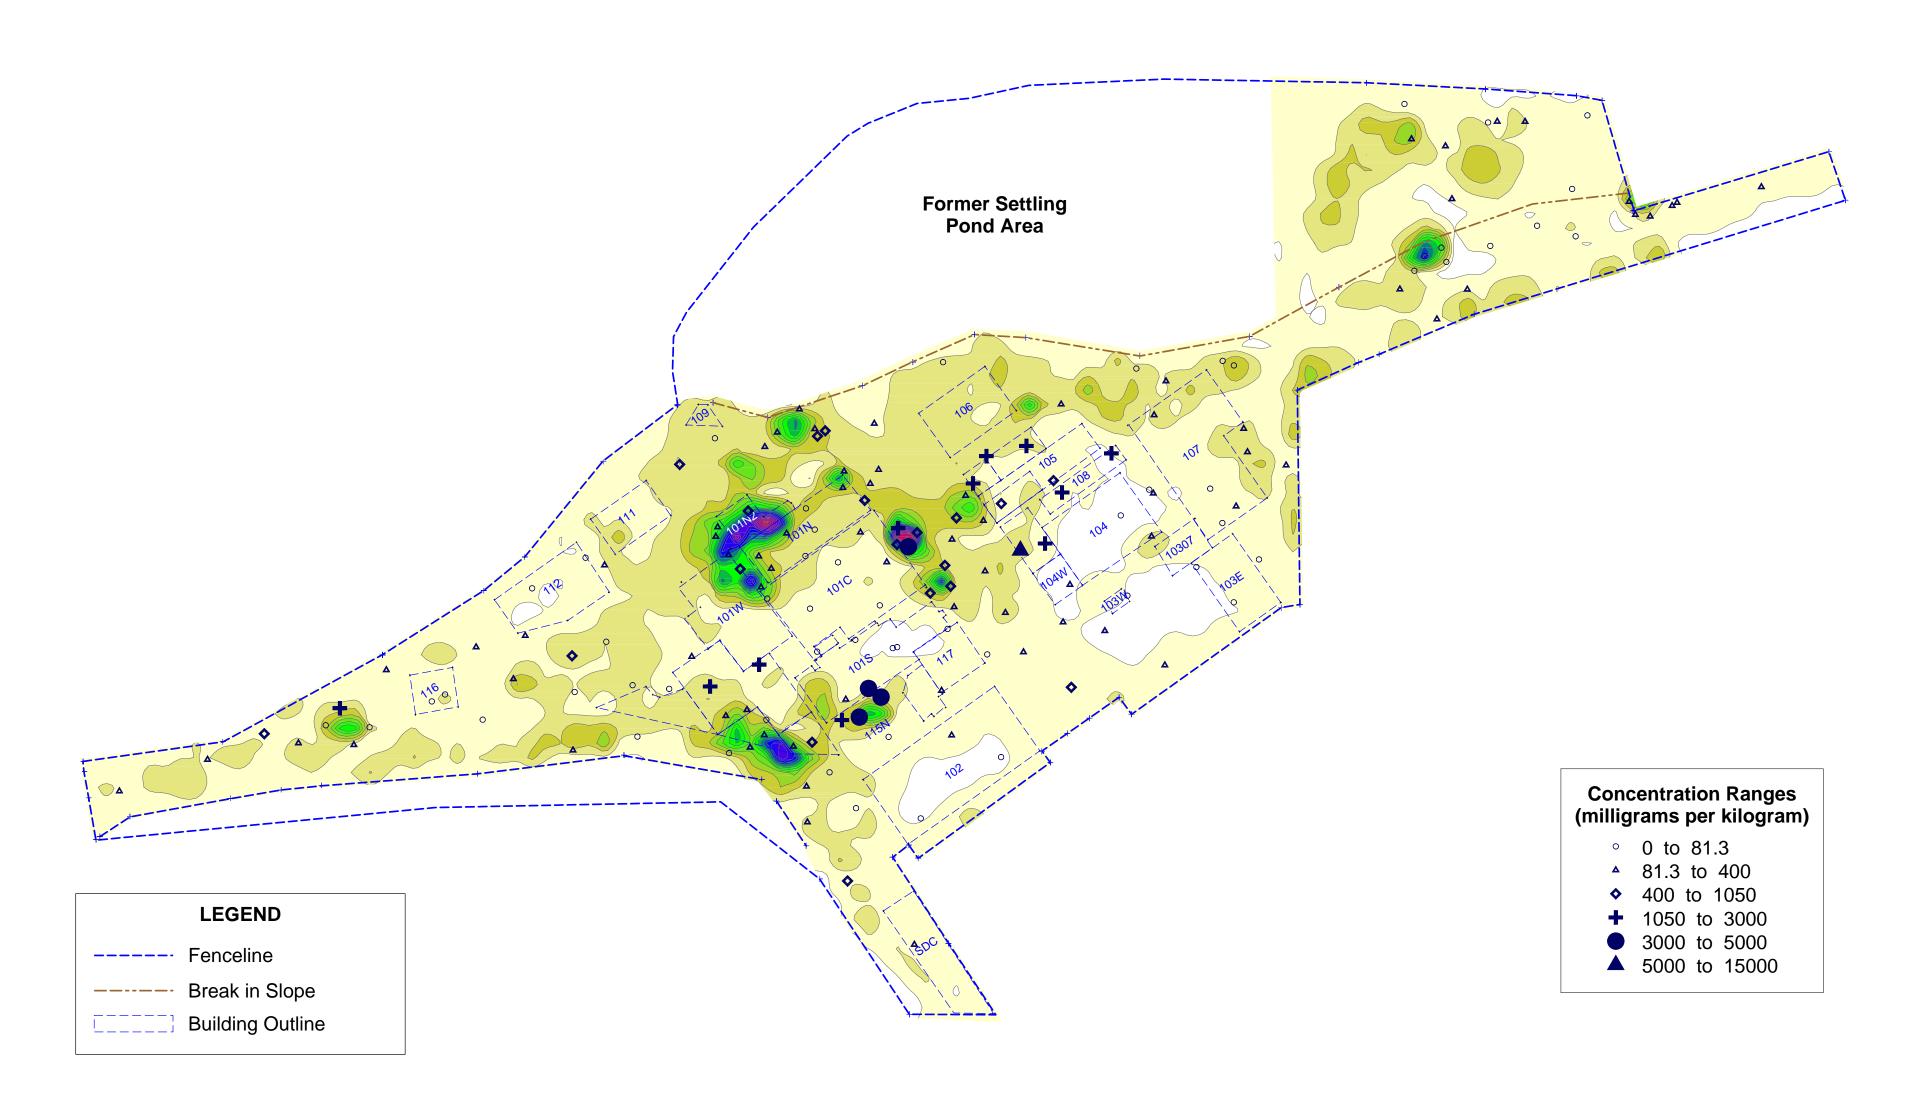
Note: Background color variations represent surface gamma distribution generated by geostatistics (kriging).
